Manhole Inspection Summary

Manhole # S41UU_015MH

Location Address: **1437 CARSWELL ST**

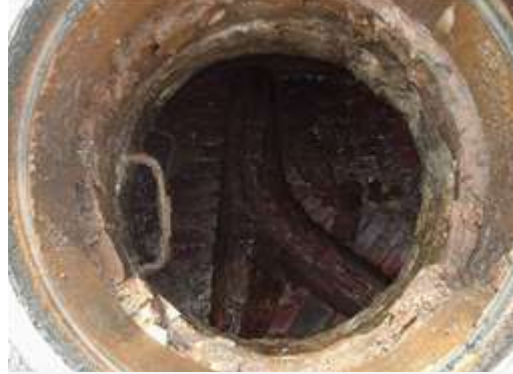
Top View

Corroded steps. Evidence of surcharge - Bench debris.

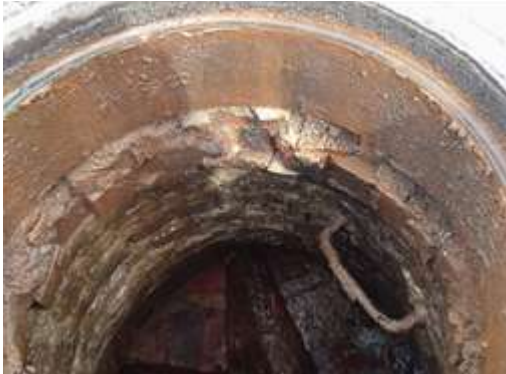
Defect

Frame leaks. Frame offset. Adjustment deterioration and infiltration - other side.

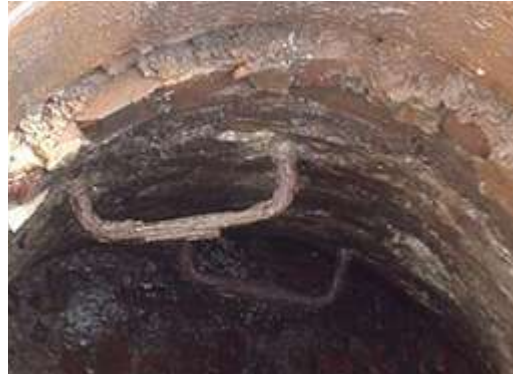
Defect

Frame leaks. Frame offset. Adjustment deterioration and infiltration.

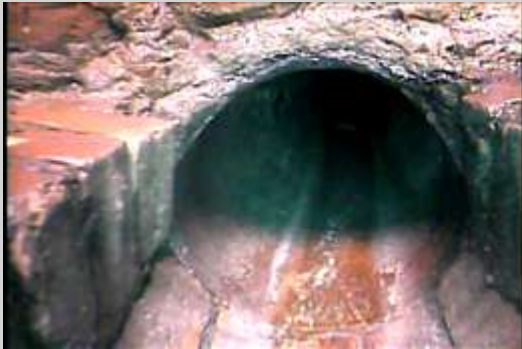
Pipe Out @ 12 O'Clock

Infiltration: **Evidence** Pipe Seal Cond: **Unknown**

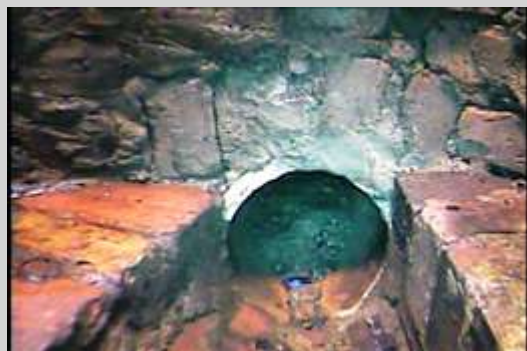
Pipe In @ 7 O'Clock

Barrel deterioration and infiltration.

Deposits: ☐ None ☒ **Mud** ☐ Sludge ☒ **Debris** ☐ Grease

Silt Depth: **1** (in.) Deposits Extent: **Light**
